Manhole Inspection Summary

Manhole # S250__026MH

Insp Date: **4/1/08 2:13 PM**

Location Address: **1352 James St**

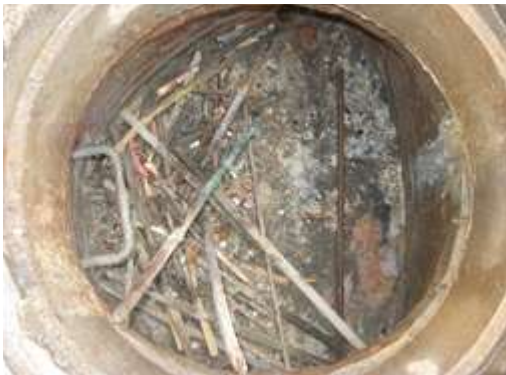
DEFECT 1

Frame Offset: **1** (in.) Condition: ☒ Sound ☐ Cracked ☐ Leaks

FRAME OFFSET

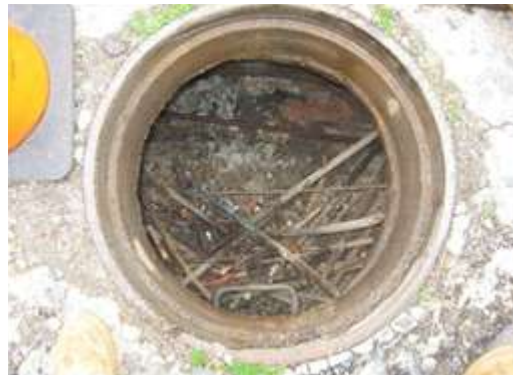
DEFECT 1

Condition: ☐ Sound ☐ Cracked ☐ Root Intrusion ☐ Deteriorated ☐ Leaks ☒ **Debris**

CHANNEL DEBRIS

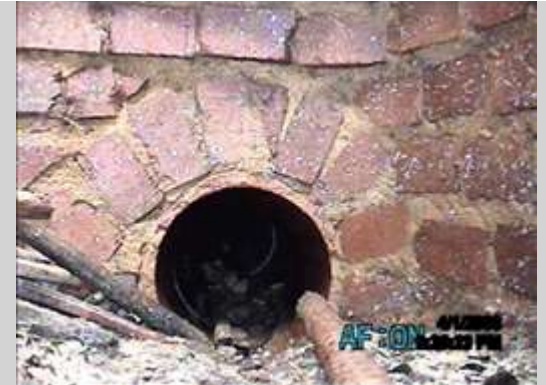
12 O'Clock Outflow

8 in. Circular Gravity Sewer
Pipe Out @ 12 O'Clock

Pipe Height: **8.4** (in.) Rod and Bar (Angled)

Pipe Material: **Clay** ☐ Pipe Lined

Invert Depth: **3.86** (ft.) Flow Characteristics: **None**

Deposits: ☒ None ☐ Mud ☐ Sludge ☐ Debris ☐ Grease

Pipe Seal Cond: **Sound**
